# School Assessment Report

District: Dolores RE-4A  
School: Dolores ES  
Date: Mar 17, 2015

### School Name: Dolores ES

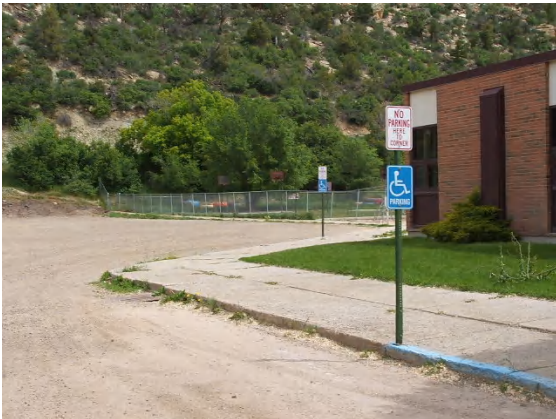
**System:** G2040 - Site Development

**Analysis:** The system is missing.

**Distress:** Missing

**Recommendation:** The system should be installed.

**Correction:** Replace and/or add fencing for security/appearance

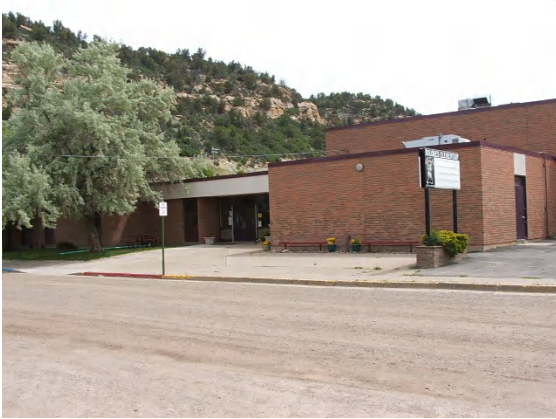
**System:** G4030 - Site Communication and Security

**Analysis:** The system is missing.

**Distress:** Missing

**Recommendation:** The system should be installed.

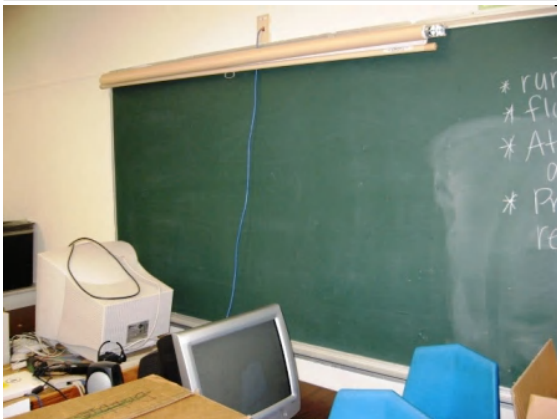
**System:** C1030 - Fittings

**Analysis:** The system age is either beyond expected life or does not meet its intended performance under the Guidelines. The system may be in service and functioning but it is recommended to be replaced due to probable increased condition budget needs, the potential failure of its components, or in order to meet the performance Guidelines for this system. The system was installed in 1968. It has a 20-year service life which expired in 1988.

**Notes:** The chalk and tack boards are beyond expected life and should be replaced.

**Recommendation:** The system should be replaced.

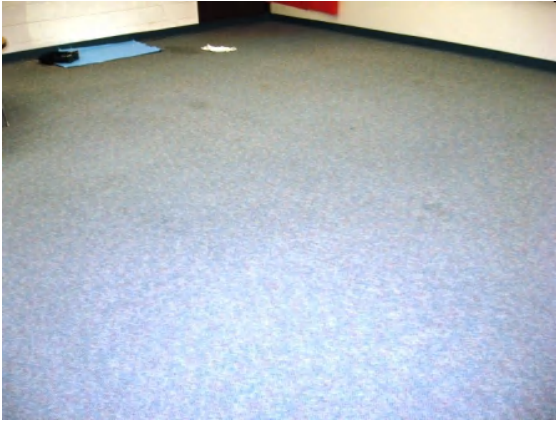
**System:** C3020 - Floor Finishes

**Analysis:** The system age is either beyond expected life or does not meet its intended performance under the Guidelines. The system may be in service and functioning but it is recommended to be replaced due to probable increased condition budget needs, the potential failure of its components, or in order to meet the performance Guidelines for this system. The system was installed in 1968. It has a 20-year service life which expired in 1988.

**Notes:** The floor finishes are beyond expected life and should be replaced.

**Recommendation:** The system should be replaced.

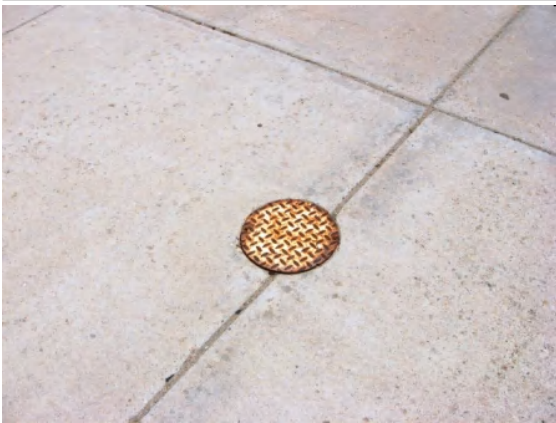
System: D2020 - Domestic Water Distribution

Analysis: The system age is either beyond expected life or does not meet its intended performance under the Guidelines. The system may be in service and functioning but it is recommended to be replaced due to probable increased condition budget needs, the potential failure of its components, or in order to meet the performance Guidelines for this system. The system was installed in 1968. It has a 30-year service life which expired in 1998.

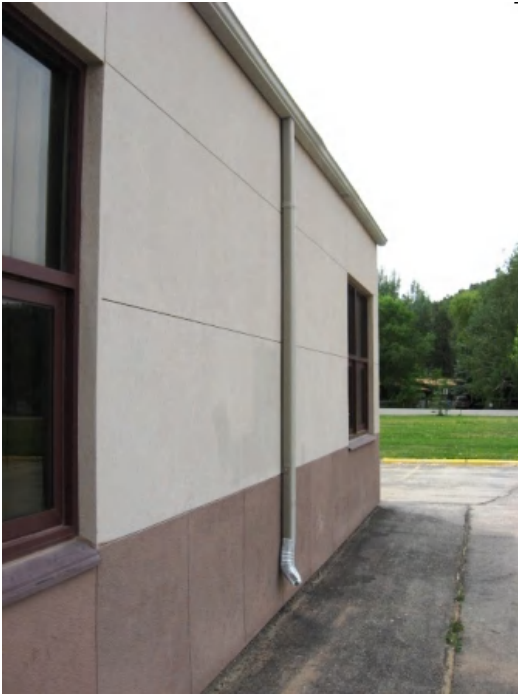
**System:** D2040 - Rain Water Drainage

**Analysis:** The system age is either beyond expected life or does not meet its intended performance under the Guidelines. The system may be in service and functioning but it is recommended to be replaced due to probable increased condition budget needs, the potential failure of its components, or in order to meet the performance Guidelines for this system. The system was installed in 1968. It has a 30-year service life which expired in 1998.

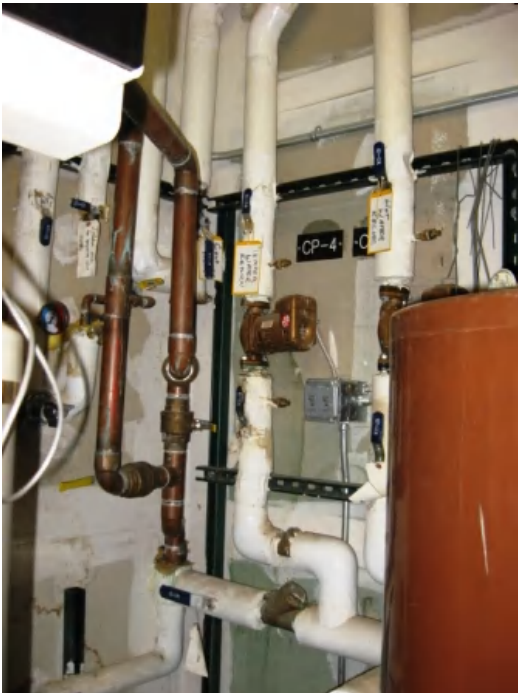
**System:** D2090 - Other Plumbing Systems

**Analysis:** The system age is either beyond expected life or does not meet its intended performance under the Guidelines. The system may be in service and functioning but it is recommended to be replaced due to probable increased condition budget needs, the potential failure of its components, or in order to meet the performance Guidelines for this system. The system was installed in 1968. It has a 20-year service life which expired in 1988.

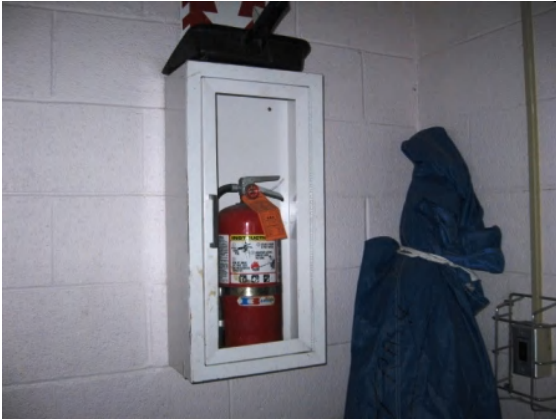
**System:** D4030 - Fire Protection Specialties

**Analysis:** The system age is either beyond expected life or does not meet its intended performance under the Guidelines. The system may be in service and functioning but it is recommended to be replaced due to probable increased condition budget needs, the potential failure of its components, or in order to meet the performance Guidelines for this system. The system was installed in 1996. It has a 15-year service life which expired in 2011.

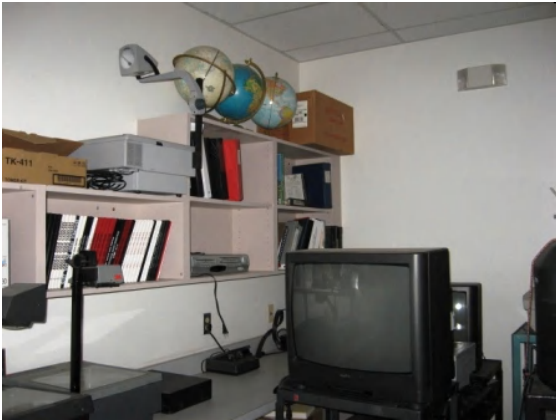
System: D5090 - Other Electrical Systems

Analysis: The system age is either beyond expected life or does not meet its intended performance under the Guidelines. The system may be in service and functioning but it is recommended to be replaced due to probable increased condition budget needs, the potential failure of its components, or in order to meet the performance Guidelines for this system. The system was installed in 1968. It has a 15-year service life which expired in 1983.

Location: Main  
Distress: Beyond Useful Life  
Category: Deferred Maintenance  
Priority: 3 - 3 Necessary- 2-5 Yrs  
Notes: The emergency lighting system is beyond expected life and should be upgraded.  
Correction: Renew System  
Qty: 1-Ea.  
Condition Budget: \$27,262

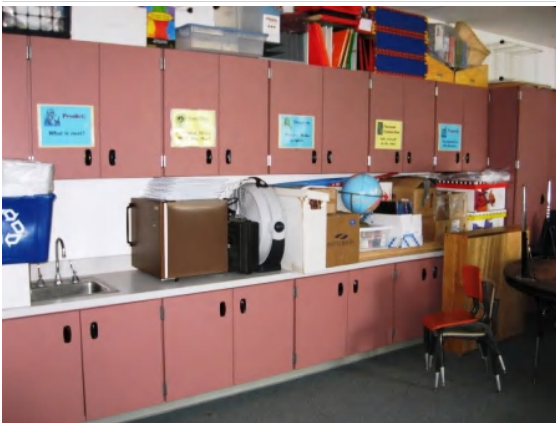
System: E2010 - Fixed Furnishings

Analysis: The system age is either beyond expected life or does not meet its intended performance under the Guidelines. The system may be in service and functioning but it is recommended to be replaced due to probable increased condition budget needs, the potential failure of its components, or in order to meet the performance Guidelines for this system. The system was installed in 1968. It has a 20-year service life which expired in 1988.

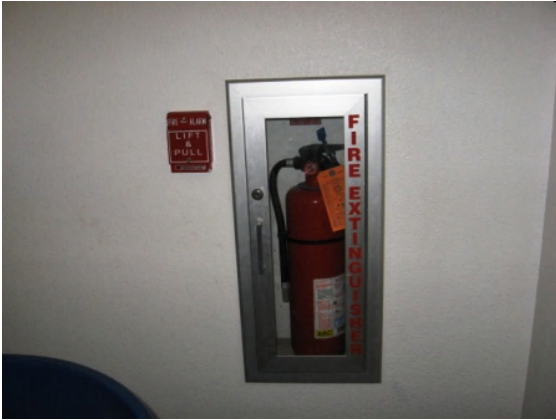
System: D4030 - Fire Protection Specialties

Analysis: The system age is either beyond expected life or does not meet its intended performance under the Guidelines. The system may be in service and functioning but it is recommended to be replaced due to probable increased condition budget needs, the potential failure of its components, or in order to meet the performance Guidelines for this system. The system was installed in 1996. It has a 15-year service life which expired in 2011.

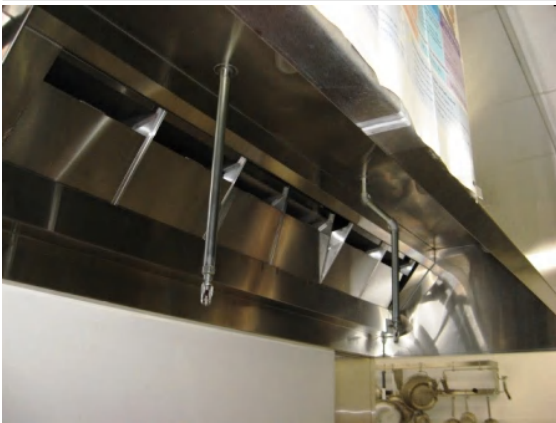
System: D4090 - Other Fire Protection Systems

Analysis: The system age is either beyond expected life or does not meet its intended performance under the Guidelines. The system may be in service and functioning but it is recommended to be replaced due to probable increased condition budget needs, the potential failure of its components, or in order to meet the performance Guidelines for this system. The system was installed in 1996. It has a 15-year service life which expired in 2011.

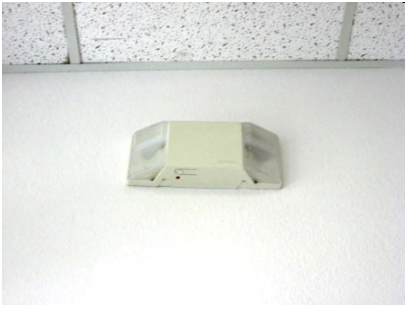
Location: 1996 Add (Commons/Library)  
Distress: Beyond Useful Life  
Category: Deferred Maintenance  
Priority: 3 - 3 Necessary- 2-5 Yrs  
Notes: The emergency lighting system is beyond expected life and should be replaced.  
Correction: Renew System  
Qty: 1-Ea.  
Condition Budget: \$9,061

Recommendation: The system should be replaced.
